TECHNICAL NOTE 4263

EFFECT OF PRIOR AIR FORCE OVERTEMPERATURE
OPERATION ON LIFE OF J47 BUCKETS EVALUATED
IN A SEA-LEVEL CYCLIC ENGINE TEST

By Robert A. Signorelli, James R. Johnston, and Floyd B. Garrett

Lewis Flight Propulsion Laboratory
Cleveland, Ohio

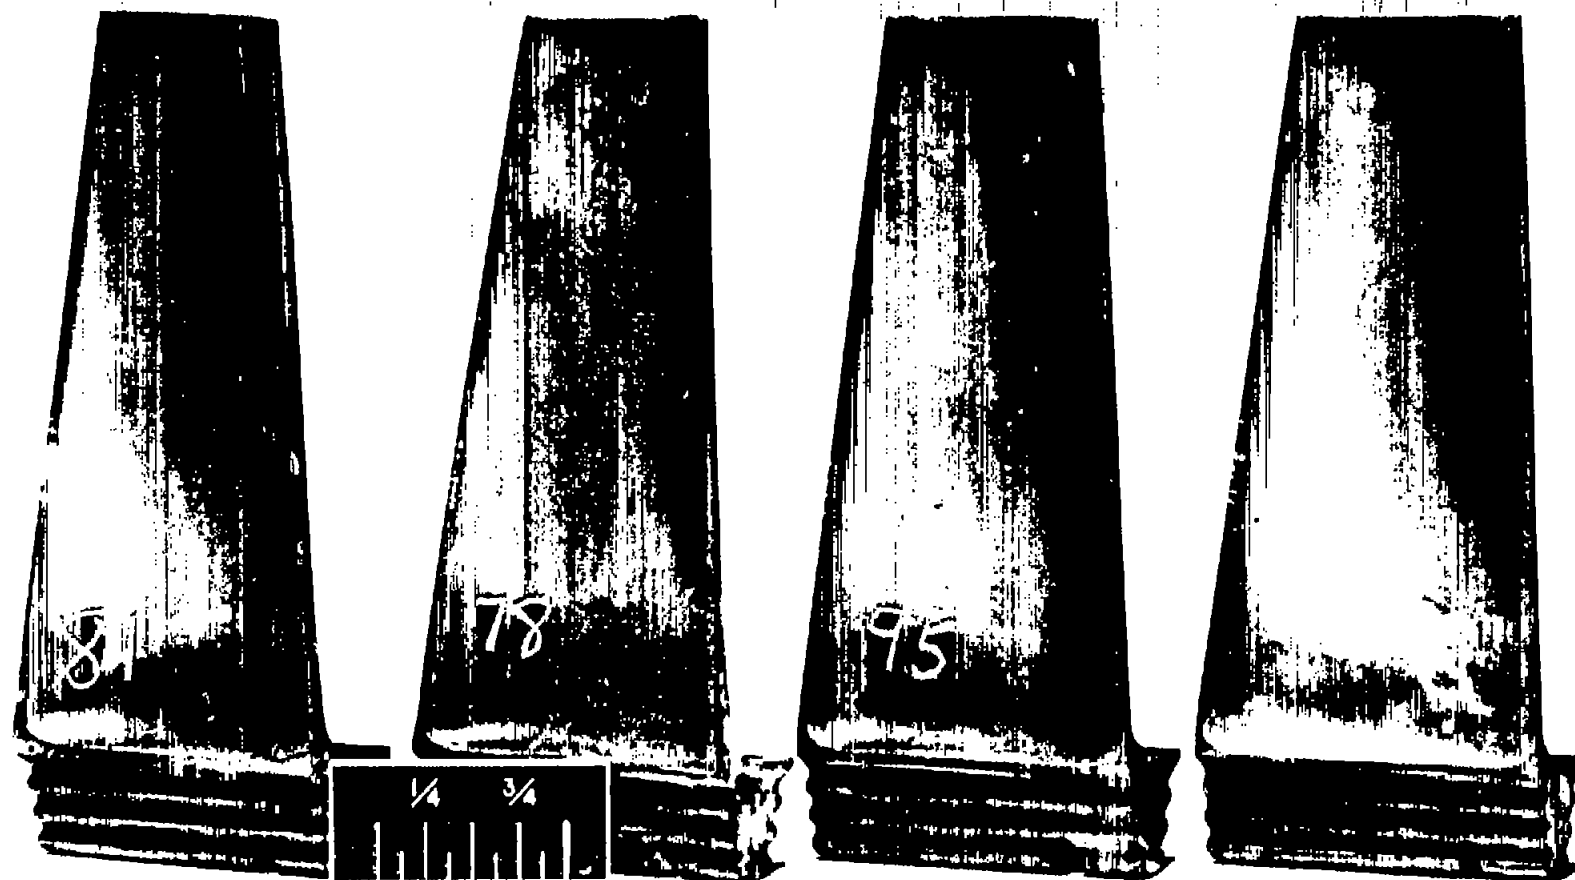
(a) Inspection, 198 hours.

Buckets ran for long periods of time without fracture after the inception of cracks. The one bucket that fractured ran 572 hours from the time cracks were first noted until it fractured. Photos of some of the buckets showing the progression of cracks during the course of the test are presented in figure 4. The depth of cracks did not increase very rapidly, as shown in figures 4(a) and (b), which illustrate the cracks after 198 and 500 hours of operation, respectively. After 500 hours, the largest leading-edge crack in bucket 81 elongated more rapidly (figs. 4(c) and (d)) and the bucket fractured in 652 hours (fig. 4(e)). The cracks in the other three buckets shown are relatively short after 660 hours, when the test was concluded (fig. 4(f)).

Figure 4. - Progression of cracks in representative buckets.

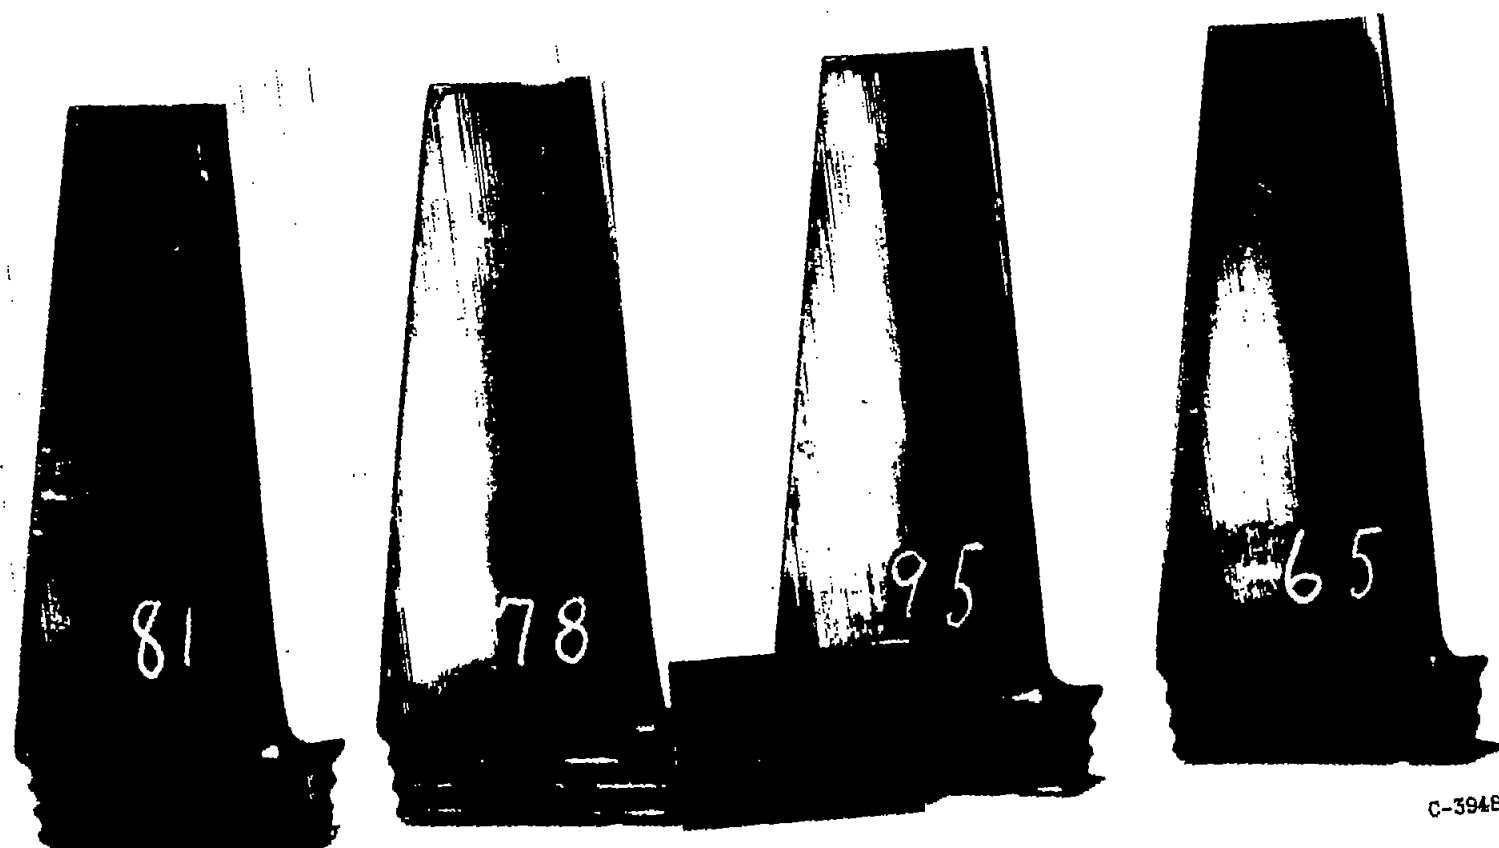
(b) Inspection, 500 hours.
Figure 4. - Continued. Progression of cracks in representative buckets.

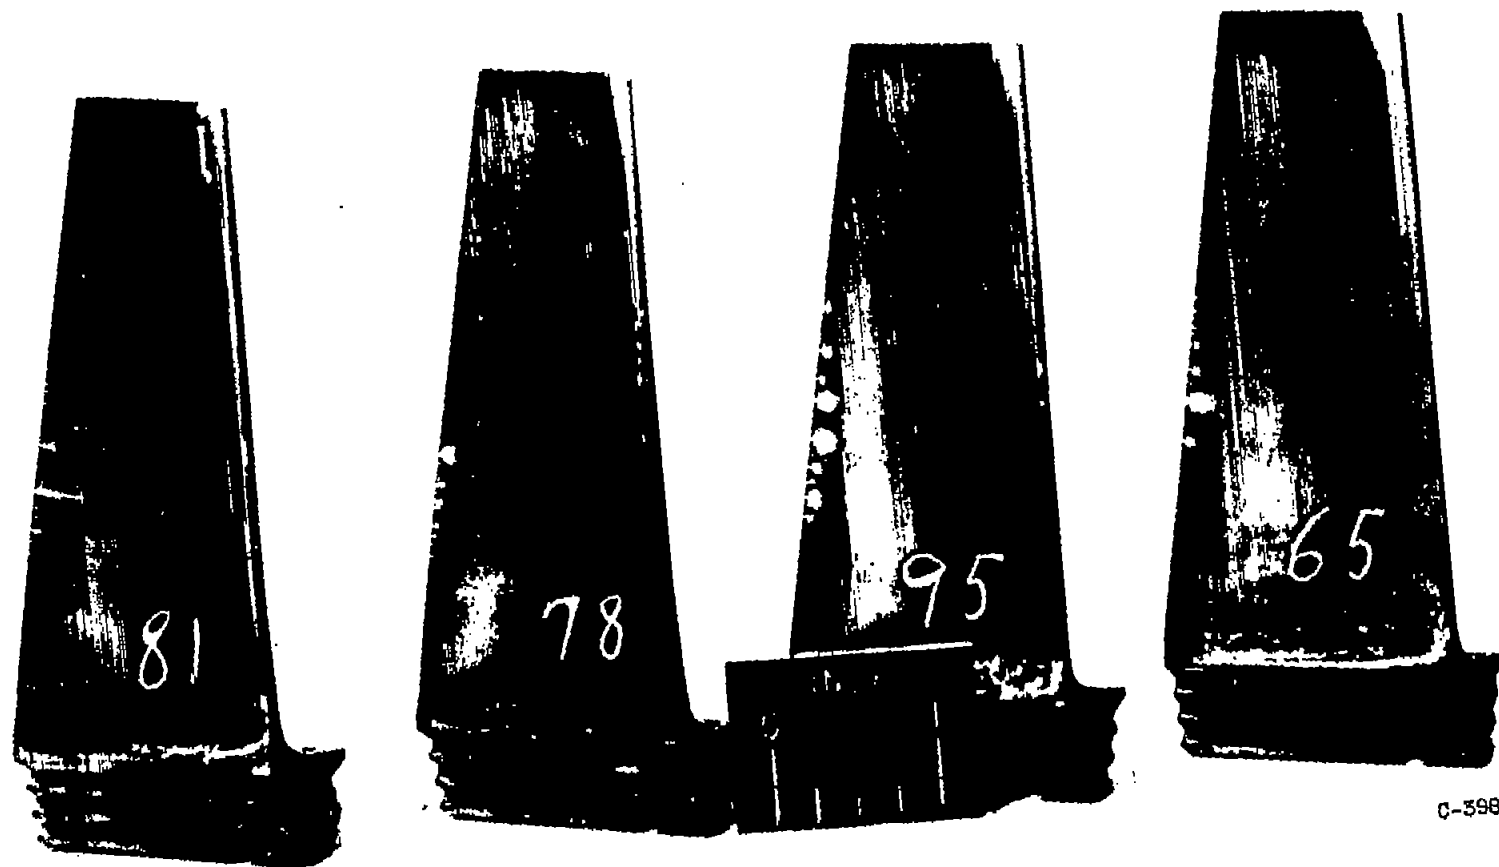
(c) Inspection, 580 hours.
Figure 4. - Continued. Progression of cracks in representative buckets.

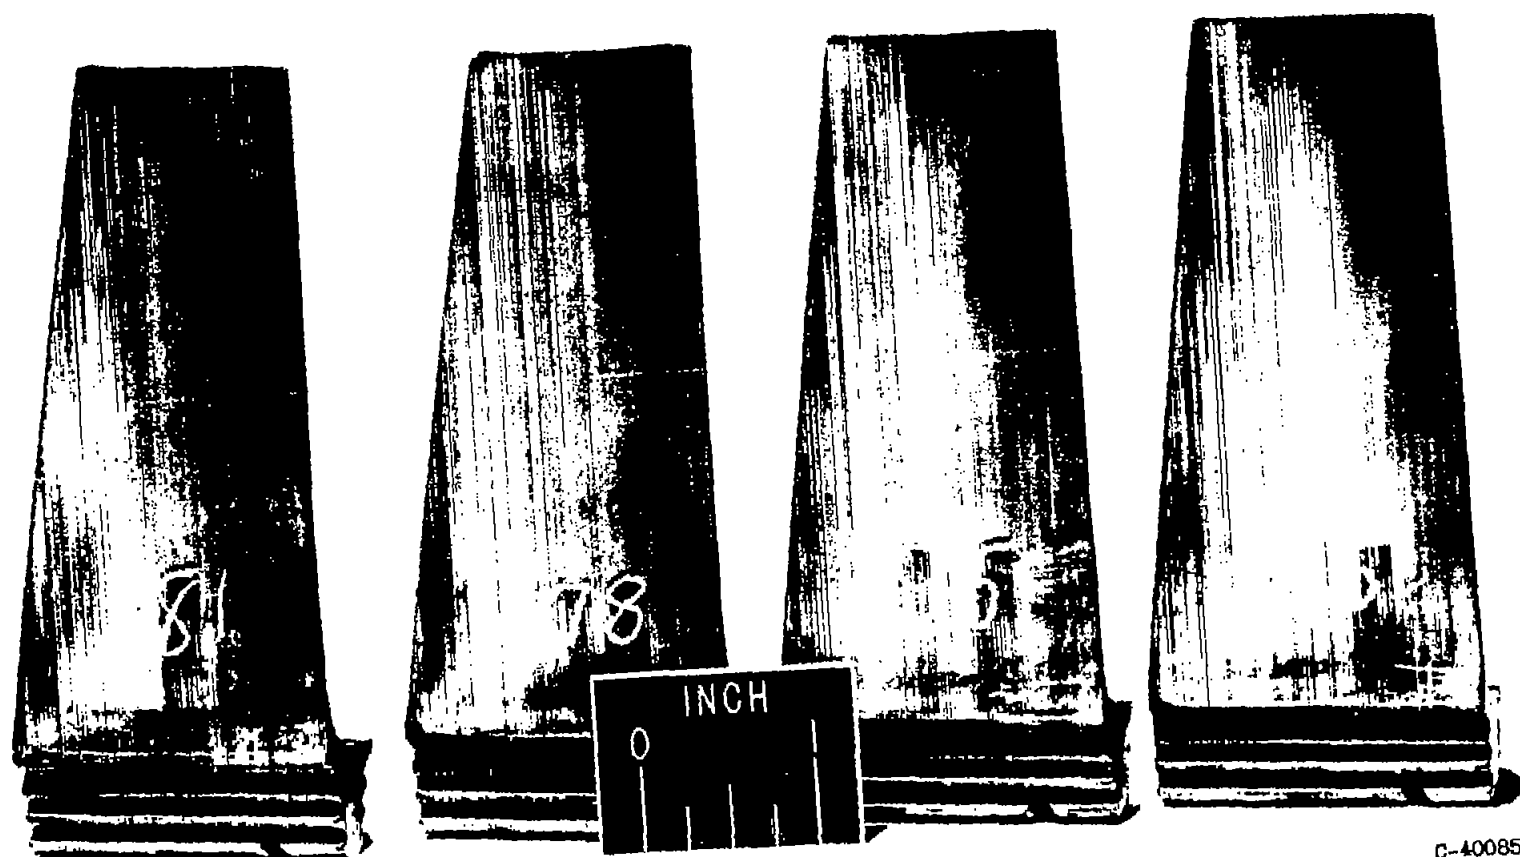
(d) Inspection, 620 hours.

Figure 4. - Continued. Progression of cracks in representative buckets.

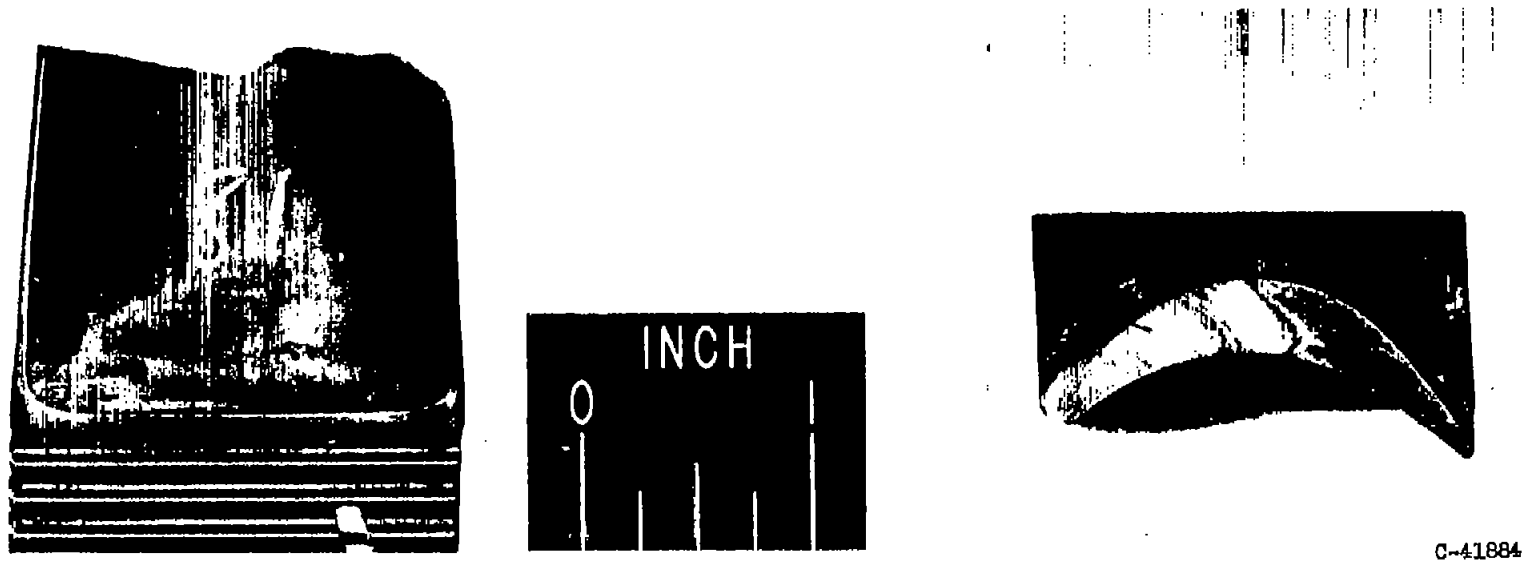
Bucket failures. - Only one bucket had fractured when the test was discontinued after 660 hours at rated speed. The fracture occurred in an overtemperated and reaged bucket (group 3) after 652 hours of operation. However, 81 buckets (84 percent) were cracked at the conclusion of the test after 660 hours (table III). Cracked buckets were first detected in the second zyglo inspection, which was performed after 80 hours. With the exception of the three buckets with trailing-edge tip cracks, all buckets were reinserted in the engine after zyglo inspection, and the test was continued to determine the rate of crack propagation.

The fracture surface of the one bucket that fractured in this investigation is shown in figure 10. The fracture surface is near the leading edge where failure began and at a point near the center of the chord length. The fracture appears intergranular near the leading edge and transgranular near midchord. The failure was propagated by fatigue from a leading-edge crack until the load-carrying area was reduced sufficiently to cause tensile failure.

(e) Bucket fracture from a leading-edge crack after 652 hours of operation.

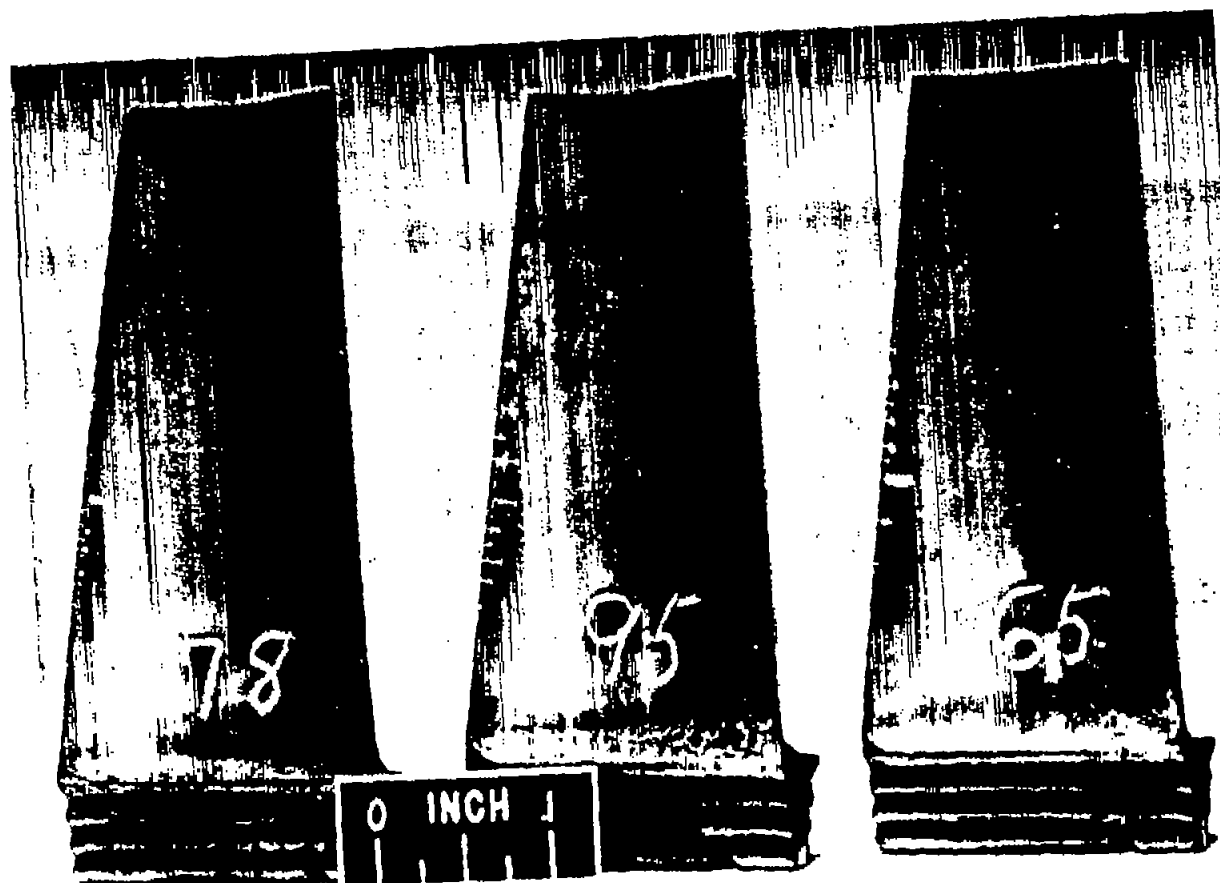
(f) Conclusion of test, 660 hours.

Figure 4. - Concluded. Progression of cracks in representative buckets.

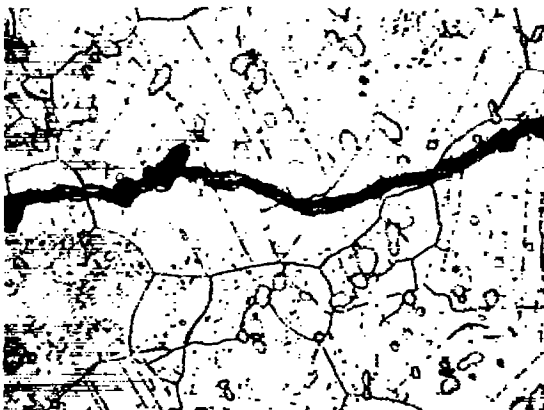
A typical radial-tip crack shown in figure 10 is a transgranular fatigue failure. Buckets ran for 500 hours with such radial-tip cracks and did not fracture.

Radial-tip cracks that developed in a number of buckets were the secondary mode of failure in this investigation. Radial-tip cracks are attributed to vibratory fatigue and generally are not associated with overtemperature. The trailing-edge tip of the bucket, where this crack occurs, undergoes relatively little temperature change compared with the midspan portion of the bucket during overtemperature; and any overtemperature effects would probably be much less severe.

(b) Radial tip crack.
